Fw 190D

Walk Around Number 10
squadron/signal publications

By E. Brown Ryle and Malcolm Laing

Focke-Wulf Fw 190D-9

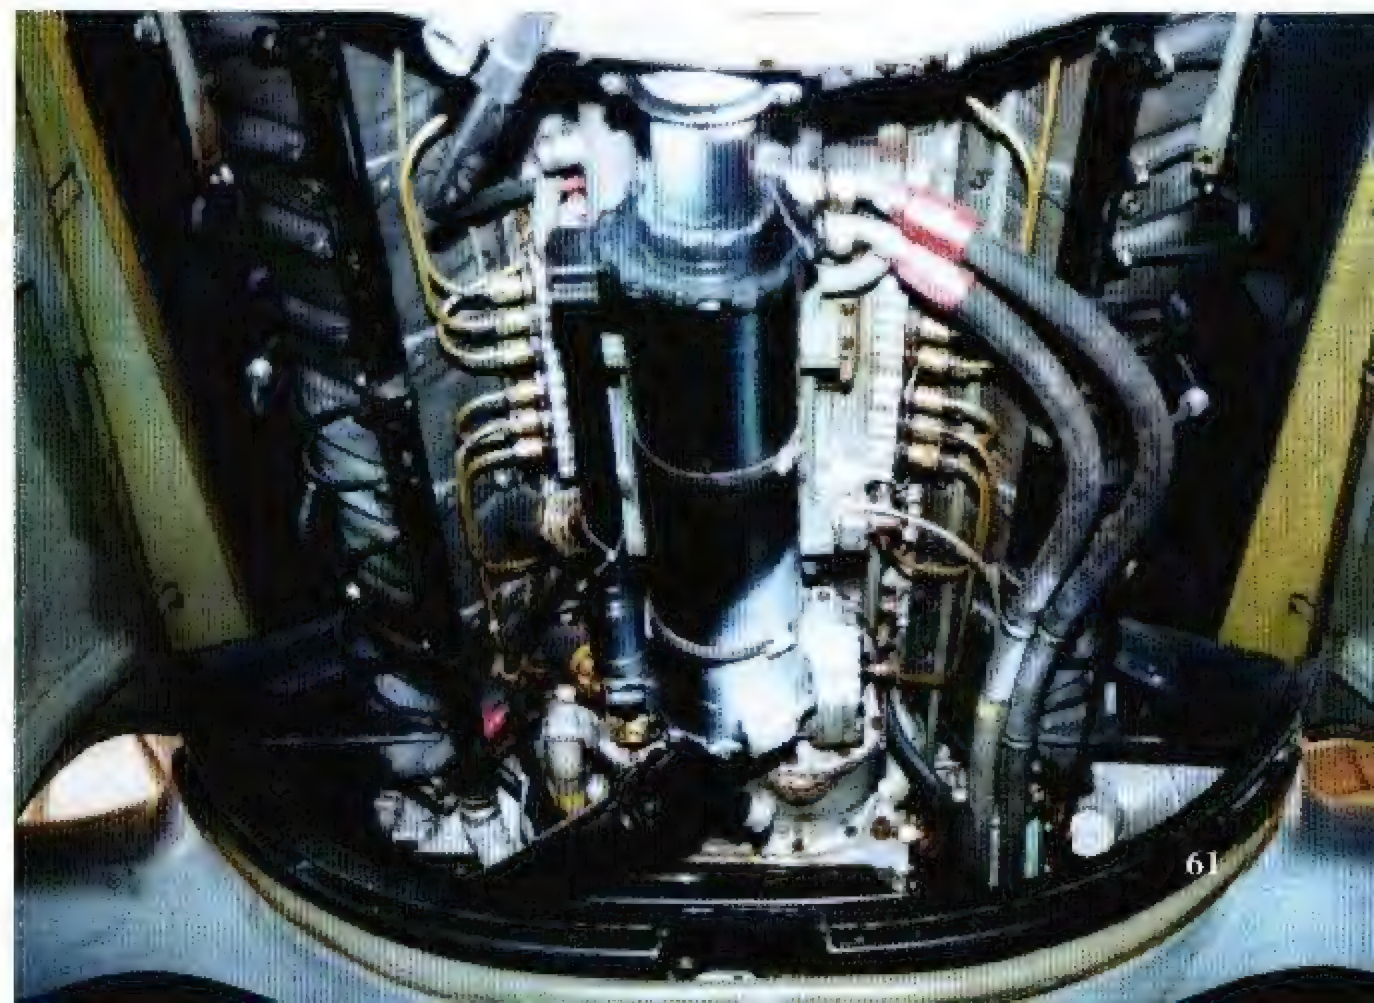
The bottom engine panels are opened providing a view of the under side of the engine from front to back. In the center are the fuel injectors, ignition harness and fuel lines. (Author: Fyle)

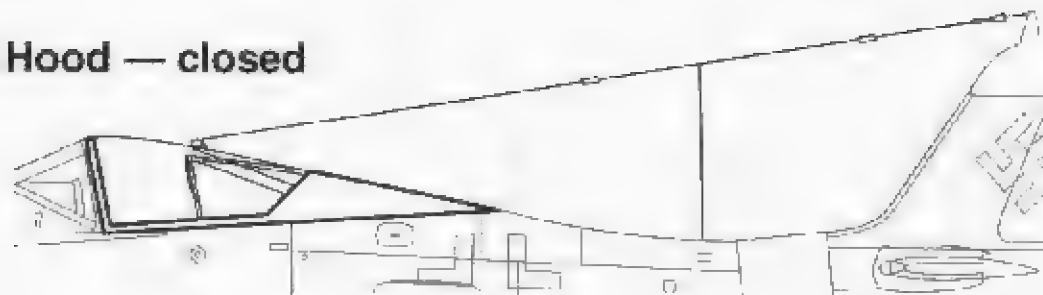
Flat Hood — closed

The two types of Fw 190 cockpit canopies. The top canopy is the early, flat style with which most Fw 190Ds left the factory. This canopy has a piano hinge at its top front to allow flexing inward without breaking when the canopy is opened and the canopy's front rollers move inward within the narrowing fuselage canopy rails. The later style, blown hood canopy is made in two pieces joined at the top via a single strip of bracing. This was a simpler construction technique providing more room and visibility while still allowing the canopy to flex on opening without breaking.

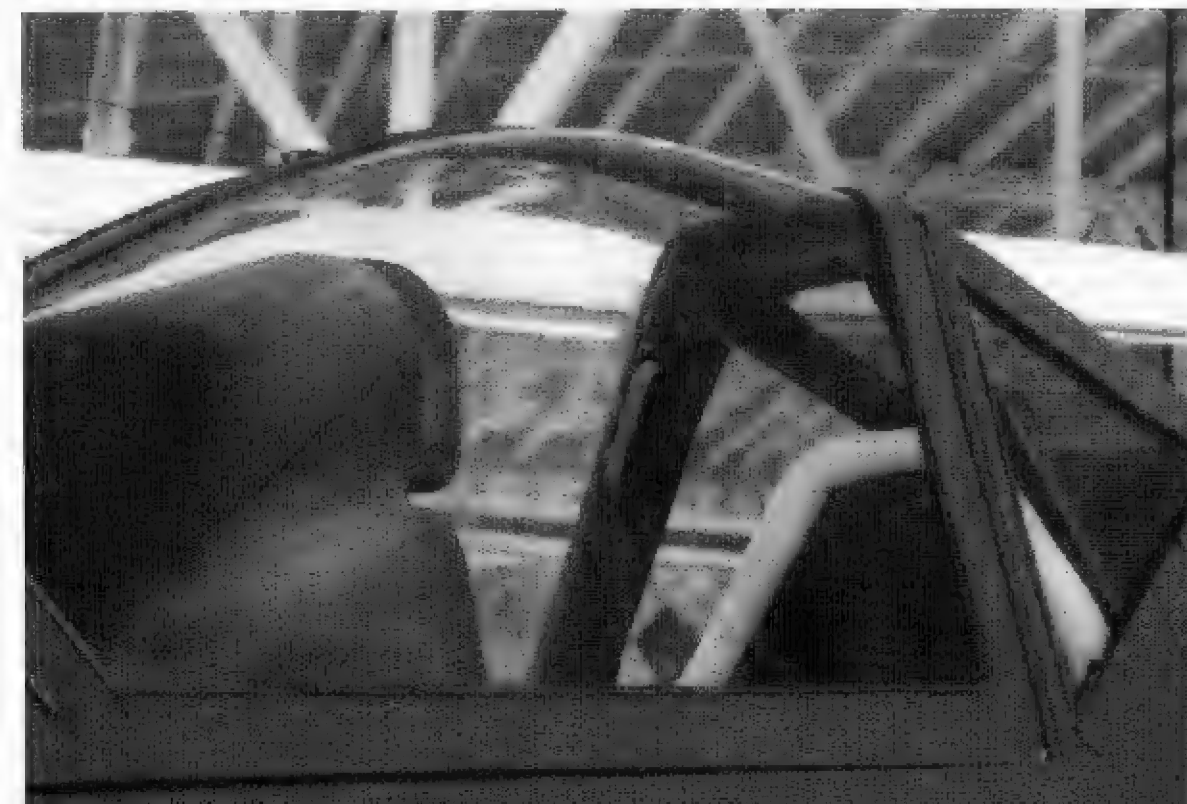
The pilot's view out of the cockpit was good above and to the sides but the forward view was limited. The very low angle of the armored windscreen and it's small size restricted forward visibility. (Author: Ryle)

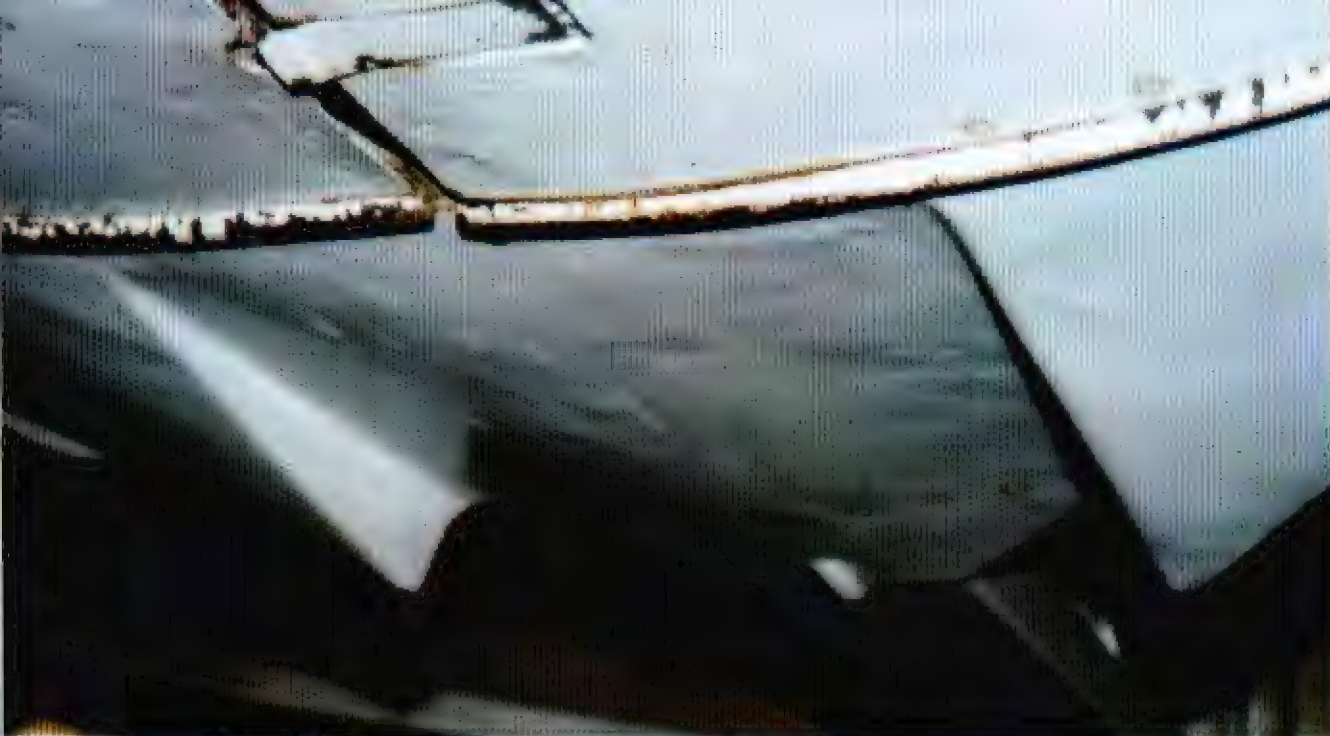
The two raised sections in front of the wheel well are a design feature left over from the radial engine of the Fw 190A series which served to channel the exhaust from the lower exhaust bank of the BMW 801 radial engine. A smooth panel for this area was designed for the D series aircraft, but since the wings of the Fw 190 A and D were the same, and the parts interchangeable, this rebuilt A series wing retained this feature. The wing installed on this aircraft was not the wing used operationally by this aircraft. (Author: Ryle)

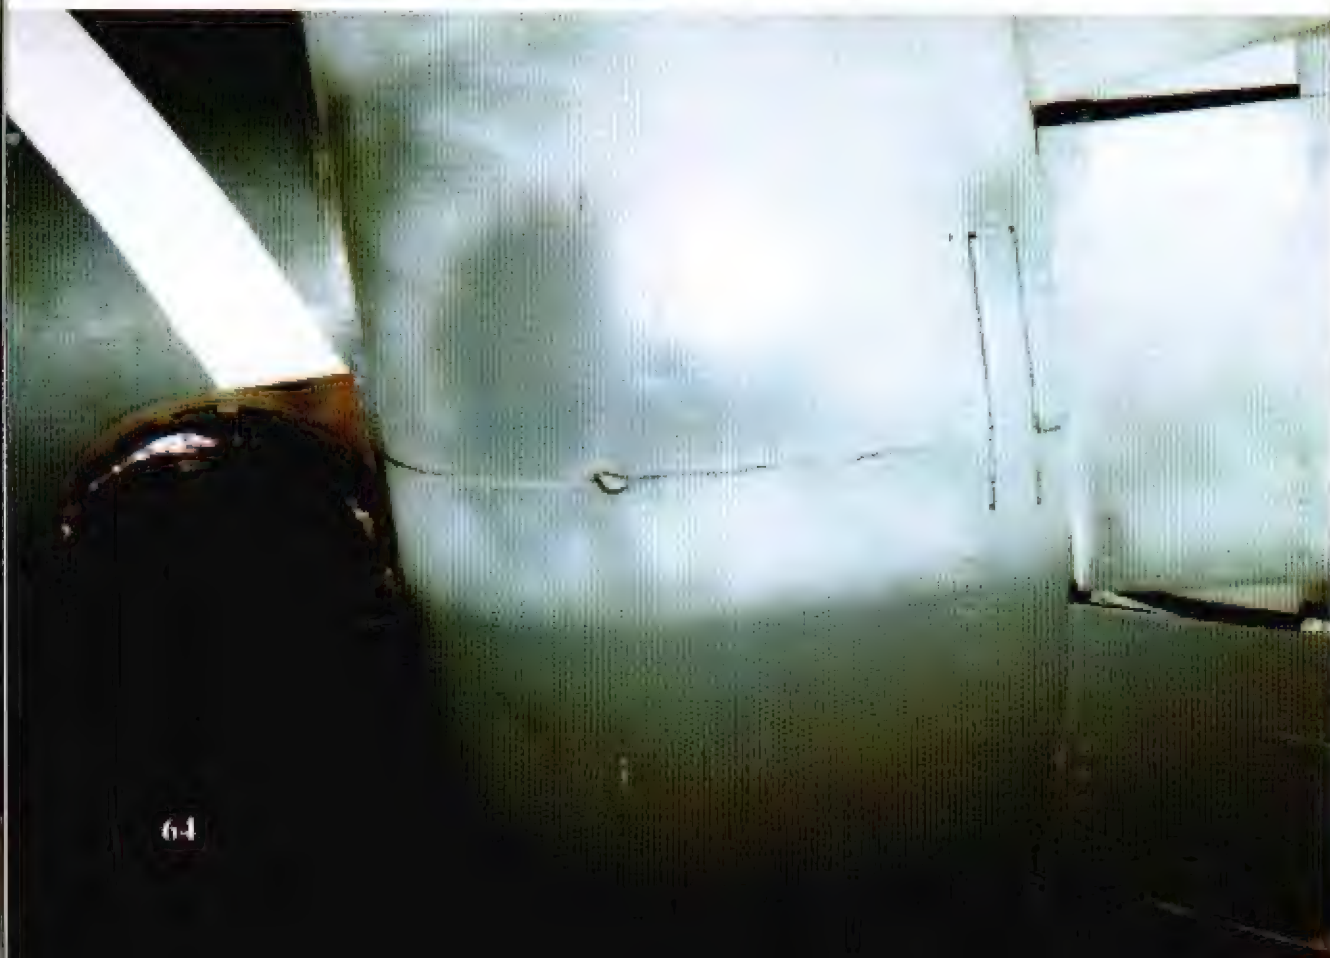
The starboard wheel well. The dimpled patterned wheel well center panels used on the earlier Fw 190A series were not retained on the Fw 190D — the mass of hoses and wiring at the aft end of the Jumo 213 engine can be seen where these panels were removed. The gray steel tube on the left of the engine opening is the motor mount. (Author: Ryle)

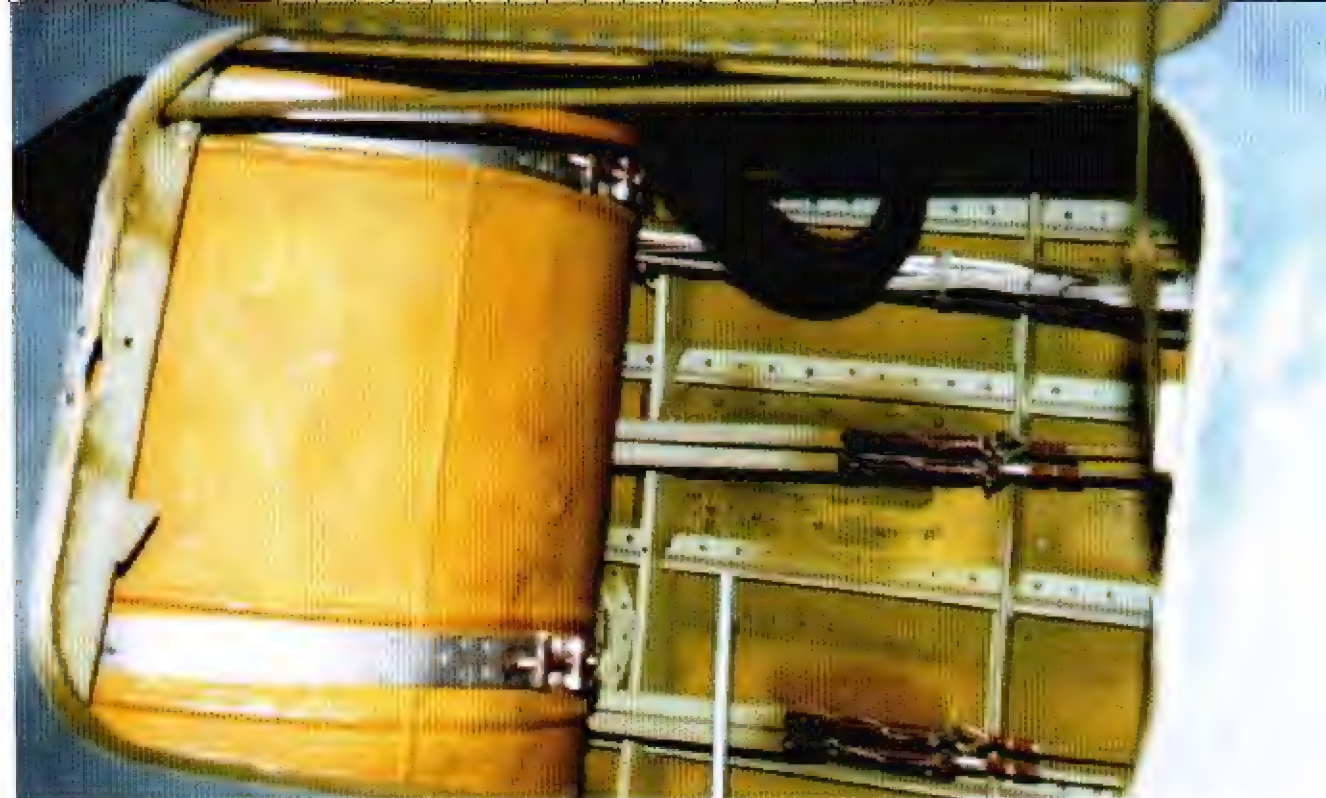
(Above and below) The additional space required to mate the Jumo 213 engine to the Fw 190D airframe was the reason the center wheel well panels could not be installed: The Jumo 213 engine and its additional plumbing required the forward and upper portion of the wheel well center. The supercharger installed on the liquid cooled Jumo in-line engine also required additional room. (Author: Ryle)

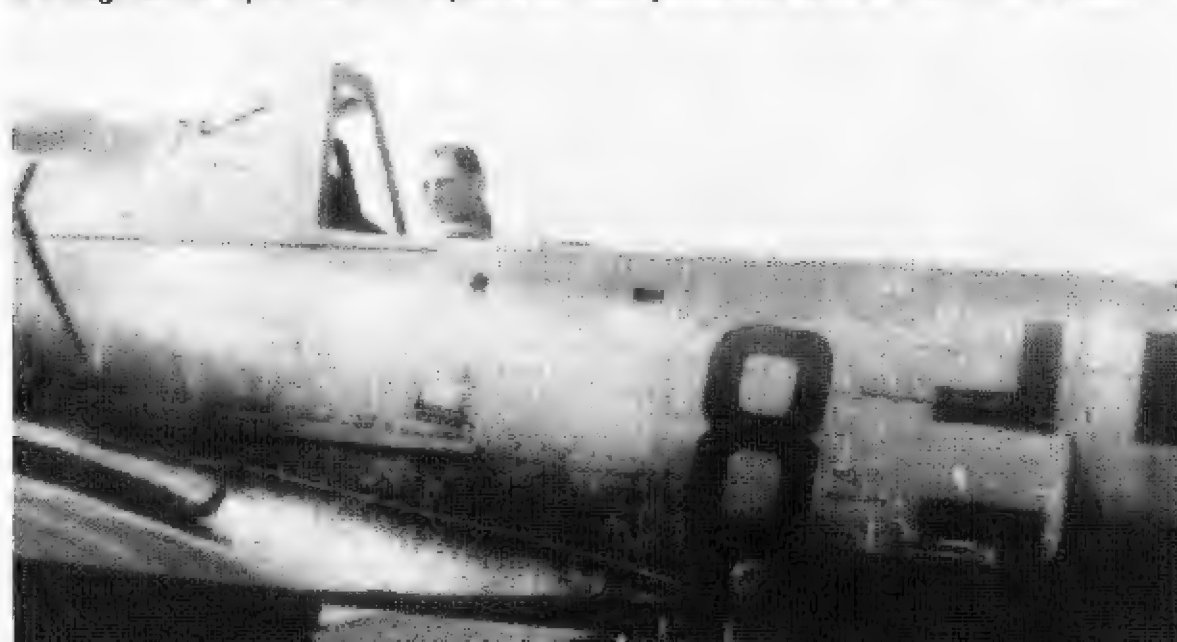
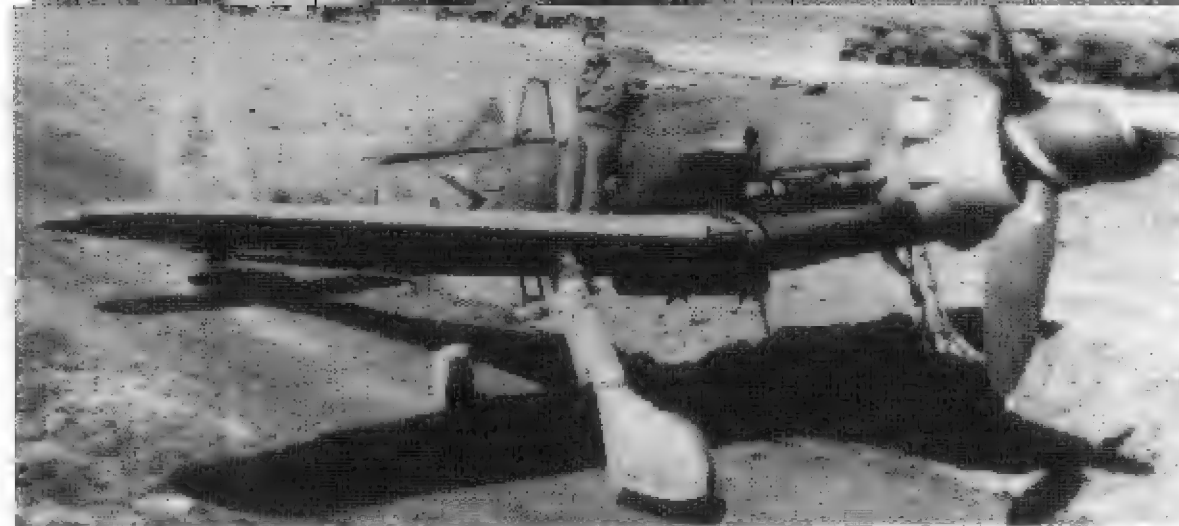
(Above and below) Black 8 (W.Nr. 500581) an Fw 190D-9 of II/JG 6 at Halle, Germany. The aft latch on cowling gun panel is open throwing a shadow onto the fuselage. Several of the cloth covers over the bolts on the port landing gear cover have not been installed, although some repair work or re-paint has been performed on the cover. (J. V. Crow)

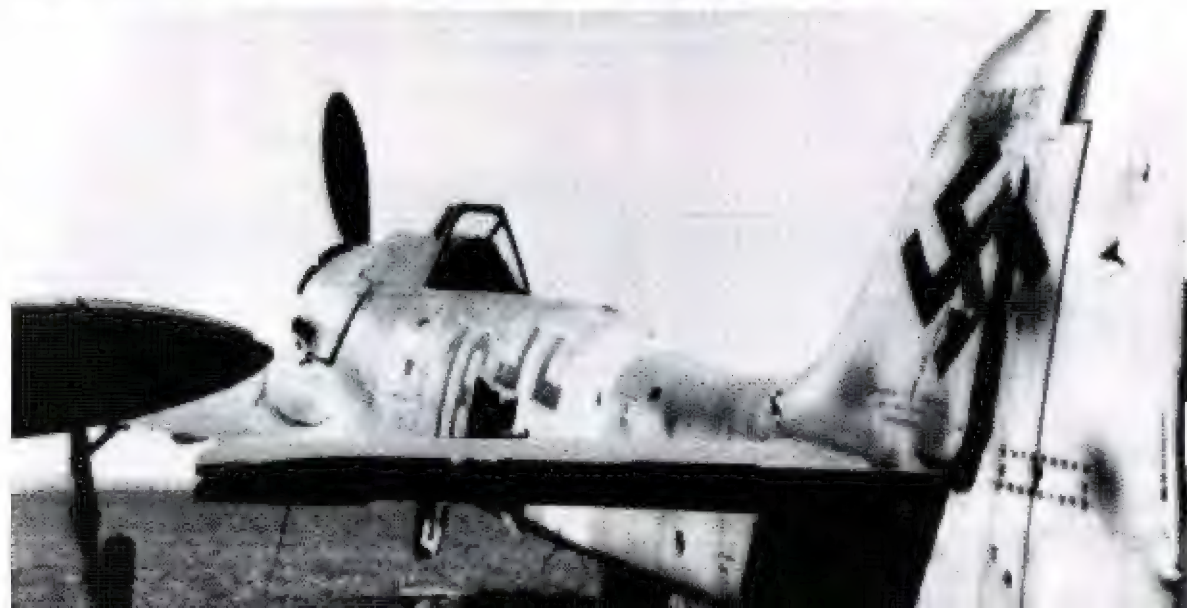
(Above and below) Black 18, an Fw 190D-9 (W.Nr. 211115) at Pilsen, Czechoslovakia in 1945, is believed to be an aircraft of JG 3. The machine has the port fuselage access panel removed as well as the radio access panel on the starboard side. Under the fuselage/wing center the 20mm ammo bay door is open and hanging down. (J. V. Crow)

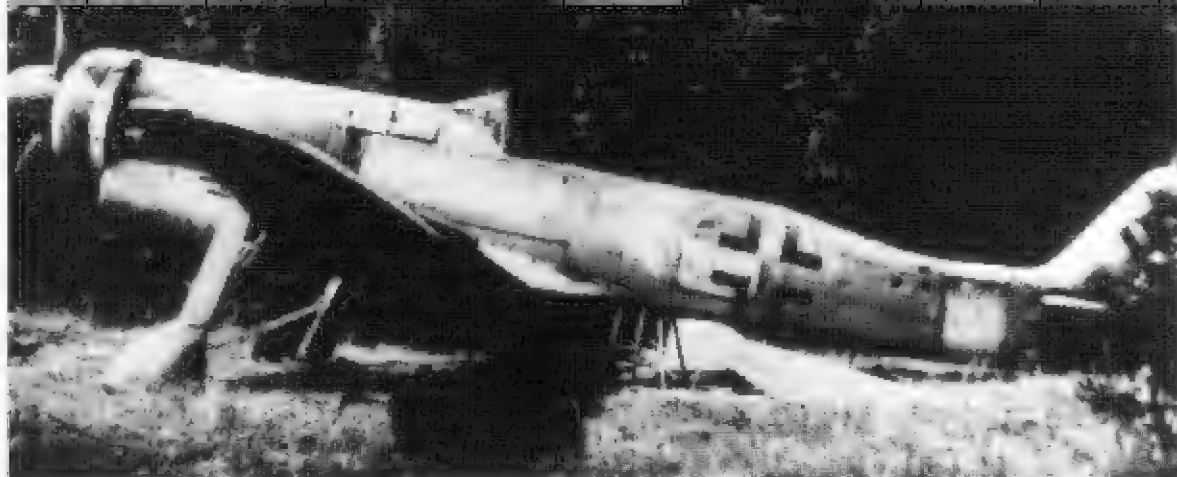
(Above) White 44 (W.Nr. 220005 or W.Nr. 220009), an Fw 190D-11 at Bad Worisholen was a high ranking officer's aircraft possibly from the Stab General der Jagdflieger. The long, flat cowling is very evident as well as the different color of the fuselage plug (heavily painted on its upper surface) added to the re-built Fw 190A fuselage for the Fw 190D fuselage configuration. (Petrick via Wadman)

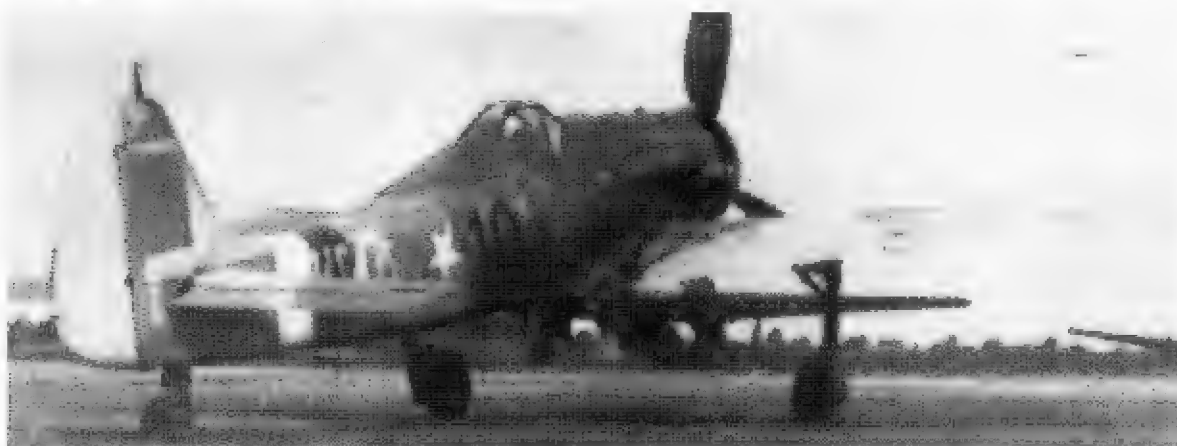
Black 10 (W.Nr. 500613), an Fw 190D-9 of III/JG 26 found at Celle, Germany. 'USA 15' and a star in white has over painted the fuselage cross position. This Work Number was not listed as being returned to the US and the fate of the aircraft is not known. (J. V. Crow)

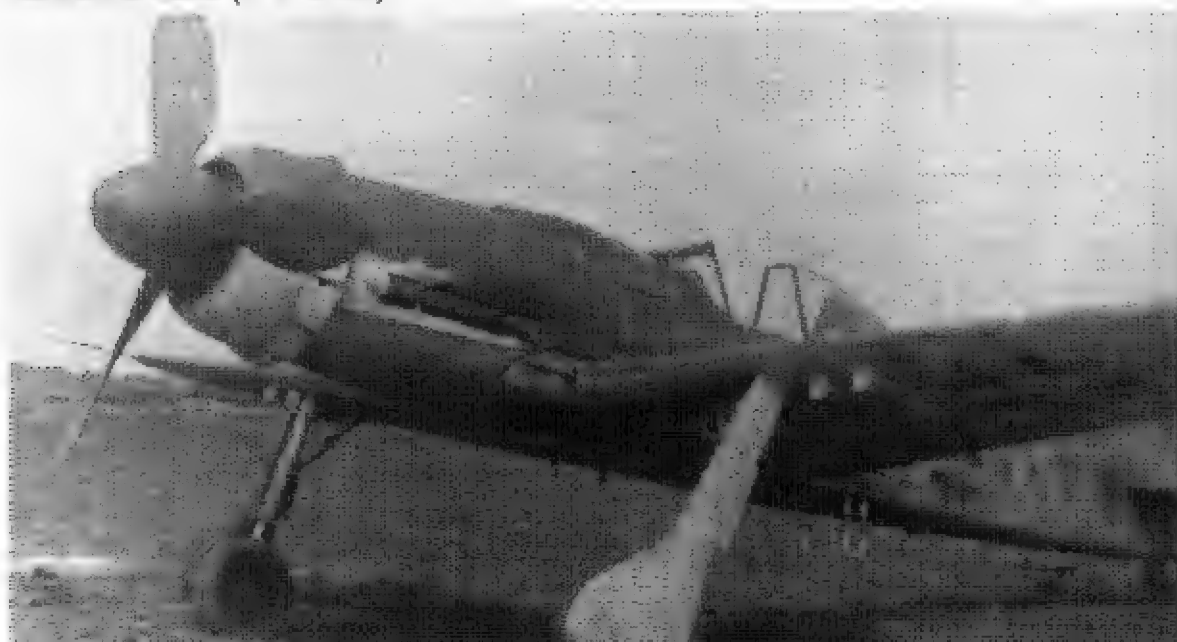
Yellow 10 (W.Nr. 836017), an Fw 190D-13 of I/JG 26. Surrendered at Flensburg, it is now on display at the Champlin Fighter Museum. The small JG 53 *Pik As* (Ace of Spades) emblem can almost be seen under the cockpit just above the leading edge of the wing. (J. Ethell via Laing)

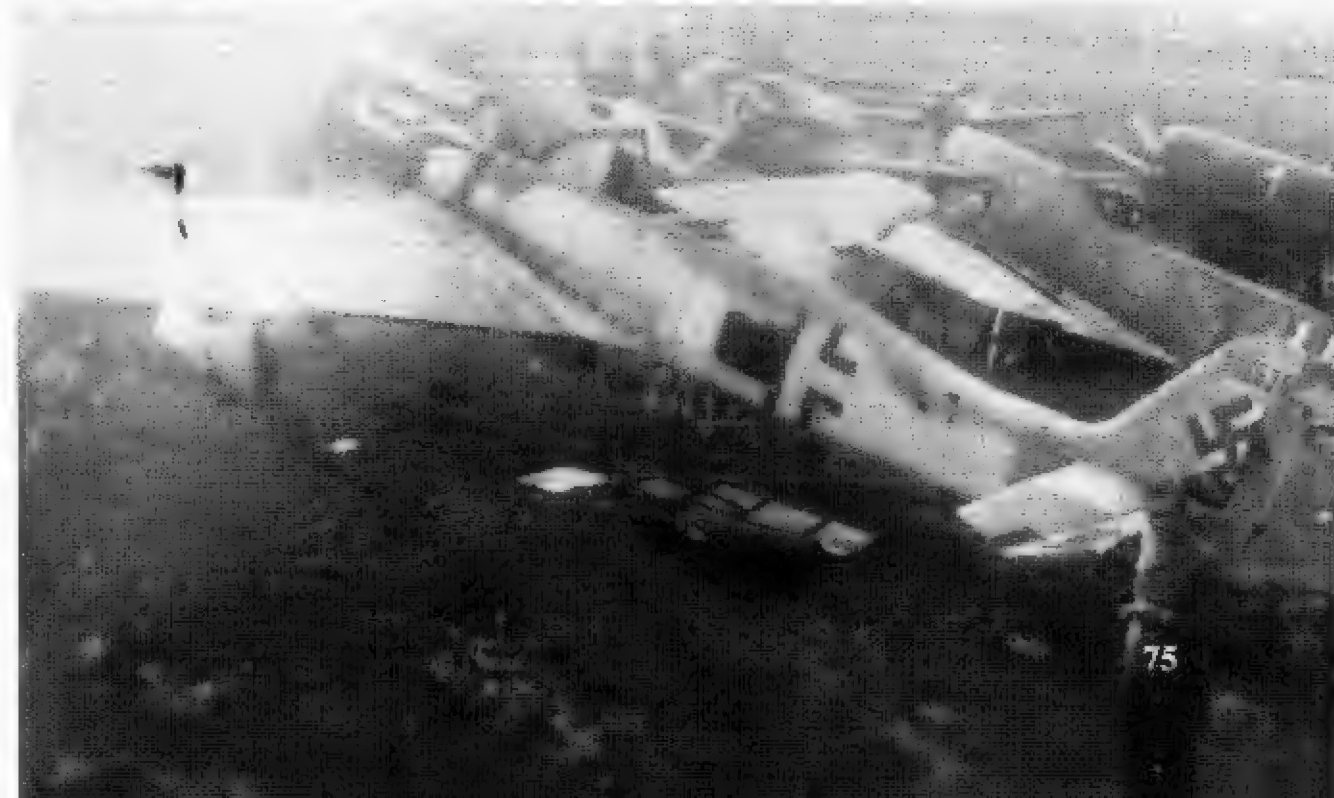
White 16, an Fw 190D-9 (500636) at Bayreuth-Blindlach, Germany during the summer of 1945. The spinner is Black with a white spiral and 70 blades. The fuselage is 83/75/76. The wing fillet is 75. The attachment bolts for the wing root cannon panel and wing root fillet are much darker than panels. The tail assembly is heavily painted with 83/75/76. The upper wing and stabilizer is 83/75.

White 16, an Fw 190D-9 (W.Nr. 500636), at Bayreuth-Bindlach, during the summer of 1945. The aircraft appears to have had the wing root 20mm cannon panel and the wing root fillet bolts painted with a much darker color than the surrounding panels. The Fw 190 to the right of white 16 has much the same in that the wing fillet is either unpainted or painted RLM 75 with dark painted attaching bolts. (J. V. Crow)

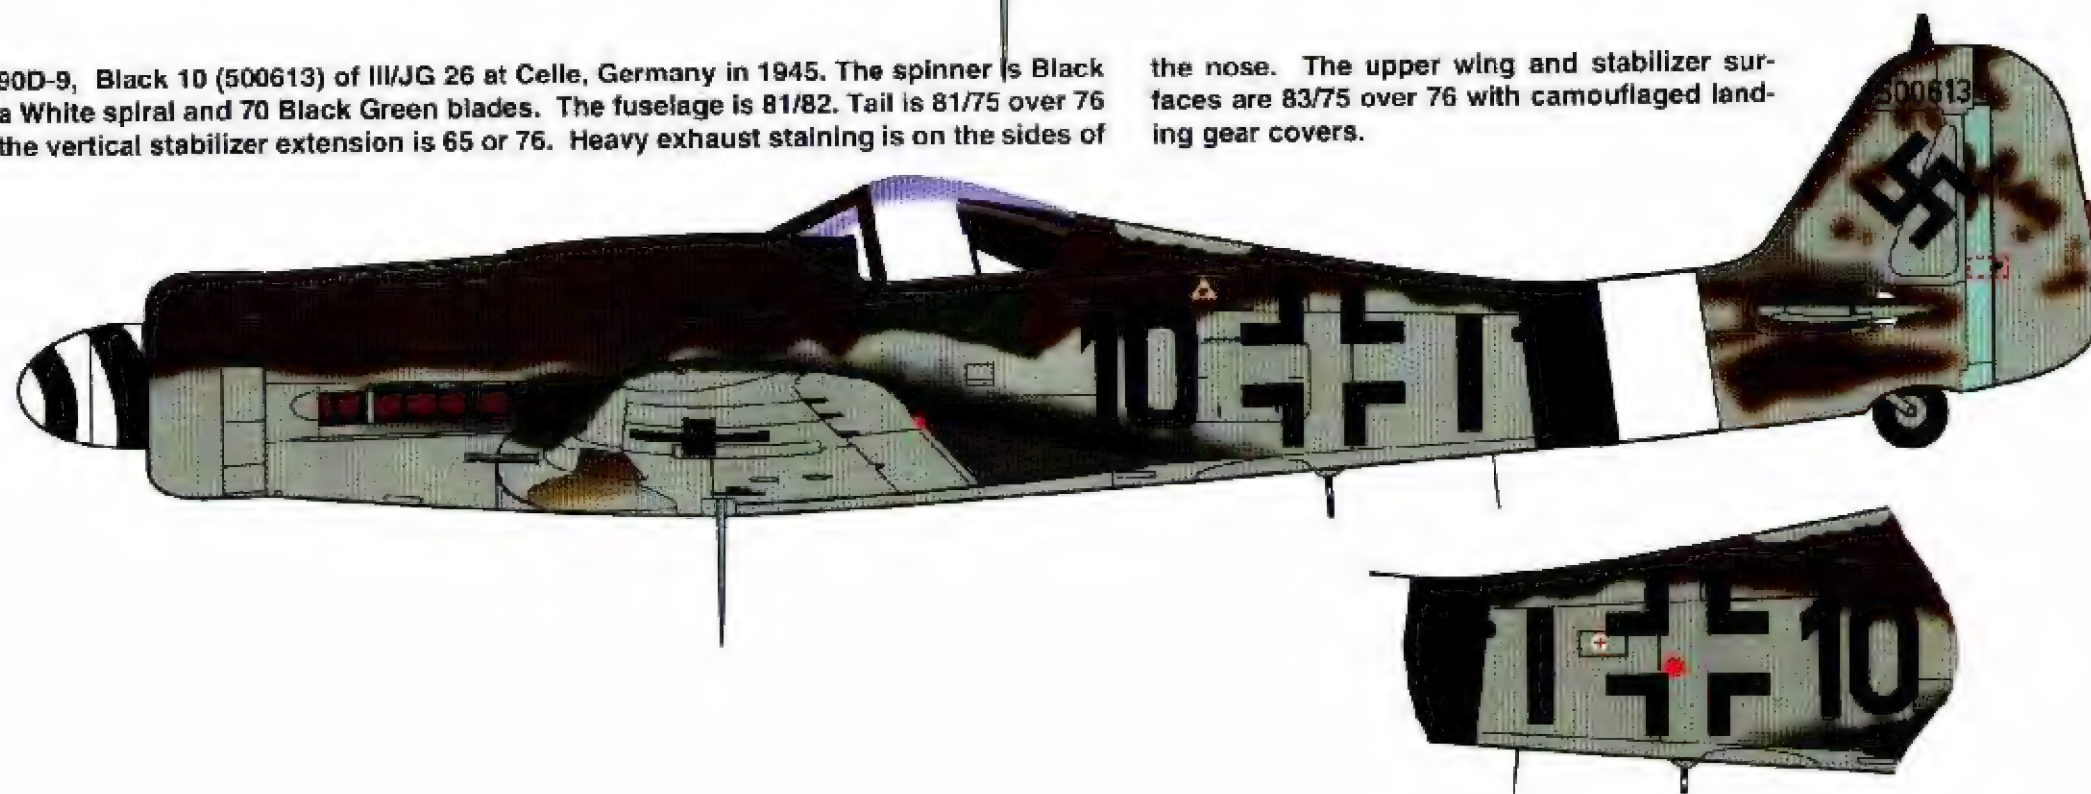
Fw 190D-9, Black 10 (500613) of III/JG 26 at Celle, Germany in 1945. The spinner is Black with a White spiral and 70 Black Green blades. The fuselage is 81/82. Tail is 81/75 over 76 with the vertical stabilizer extension is 65 or 76. Heavy exhaust staining is on the sides of

the nose. The upper wing and stabilizer surfaces are 83/75 over 76 with camouflaged landing gear covers.

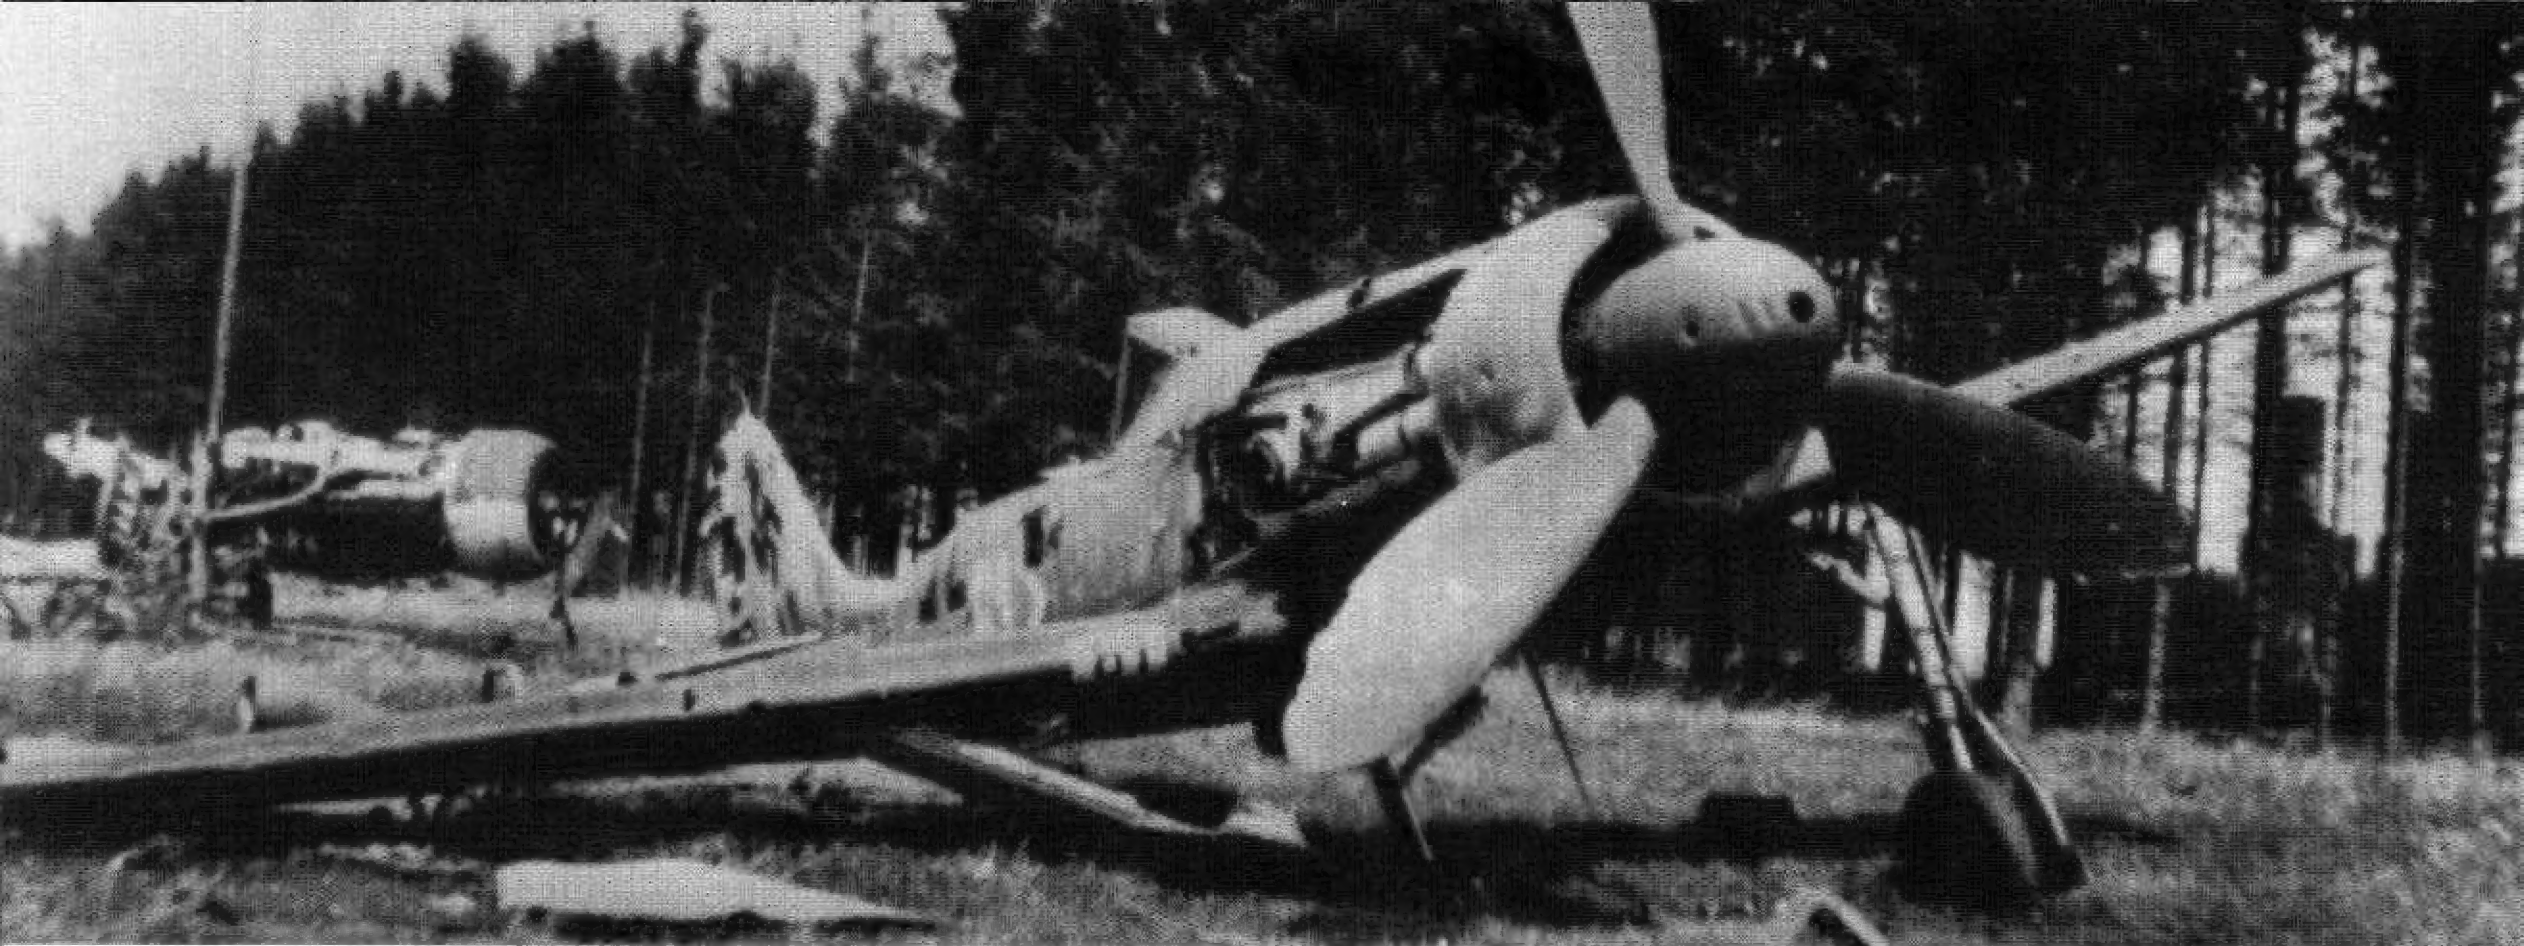
White <61, (W.Nr.350158, but possibly W.Nr. 220004) an Fw 190D-11 at Bad Worlishofen during the summer of 1945. The aircraft retains its spinner for the engine mounted cannon, but the cannon was not installed, however, the wing's 20mm inboard and 30mm out-

board cannons are clearly seen as are the unusual leading edge aircraft numbers painted just outboard of the 20mm cannons. (Petrick via Wadman)

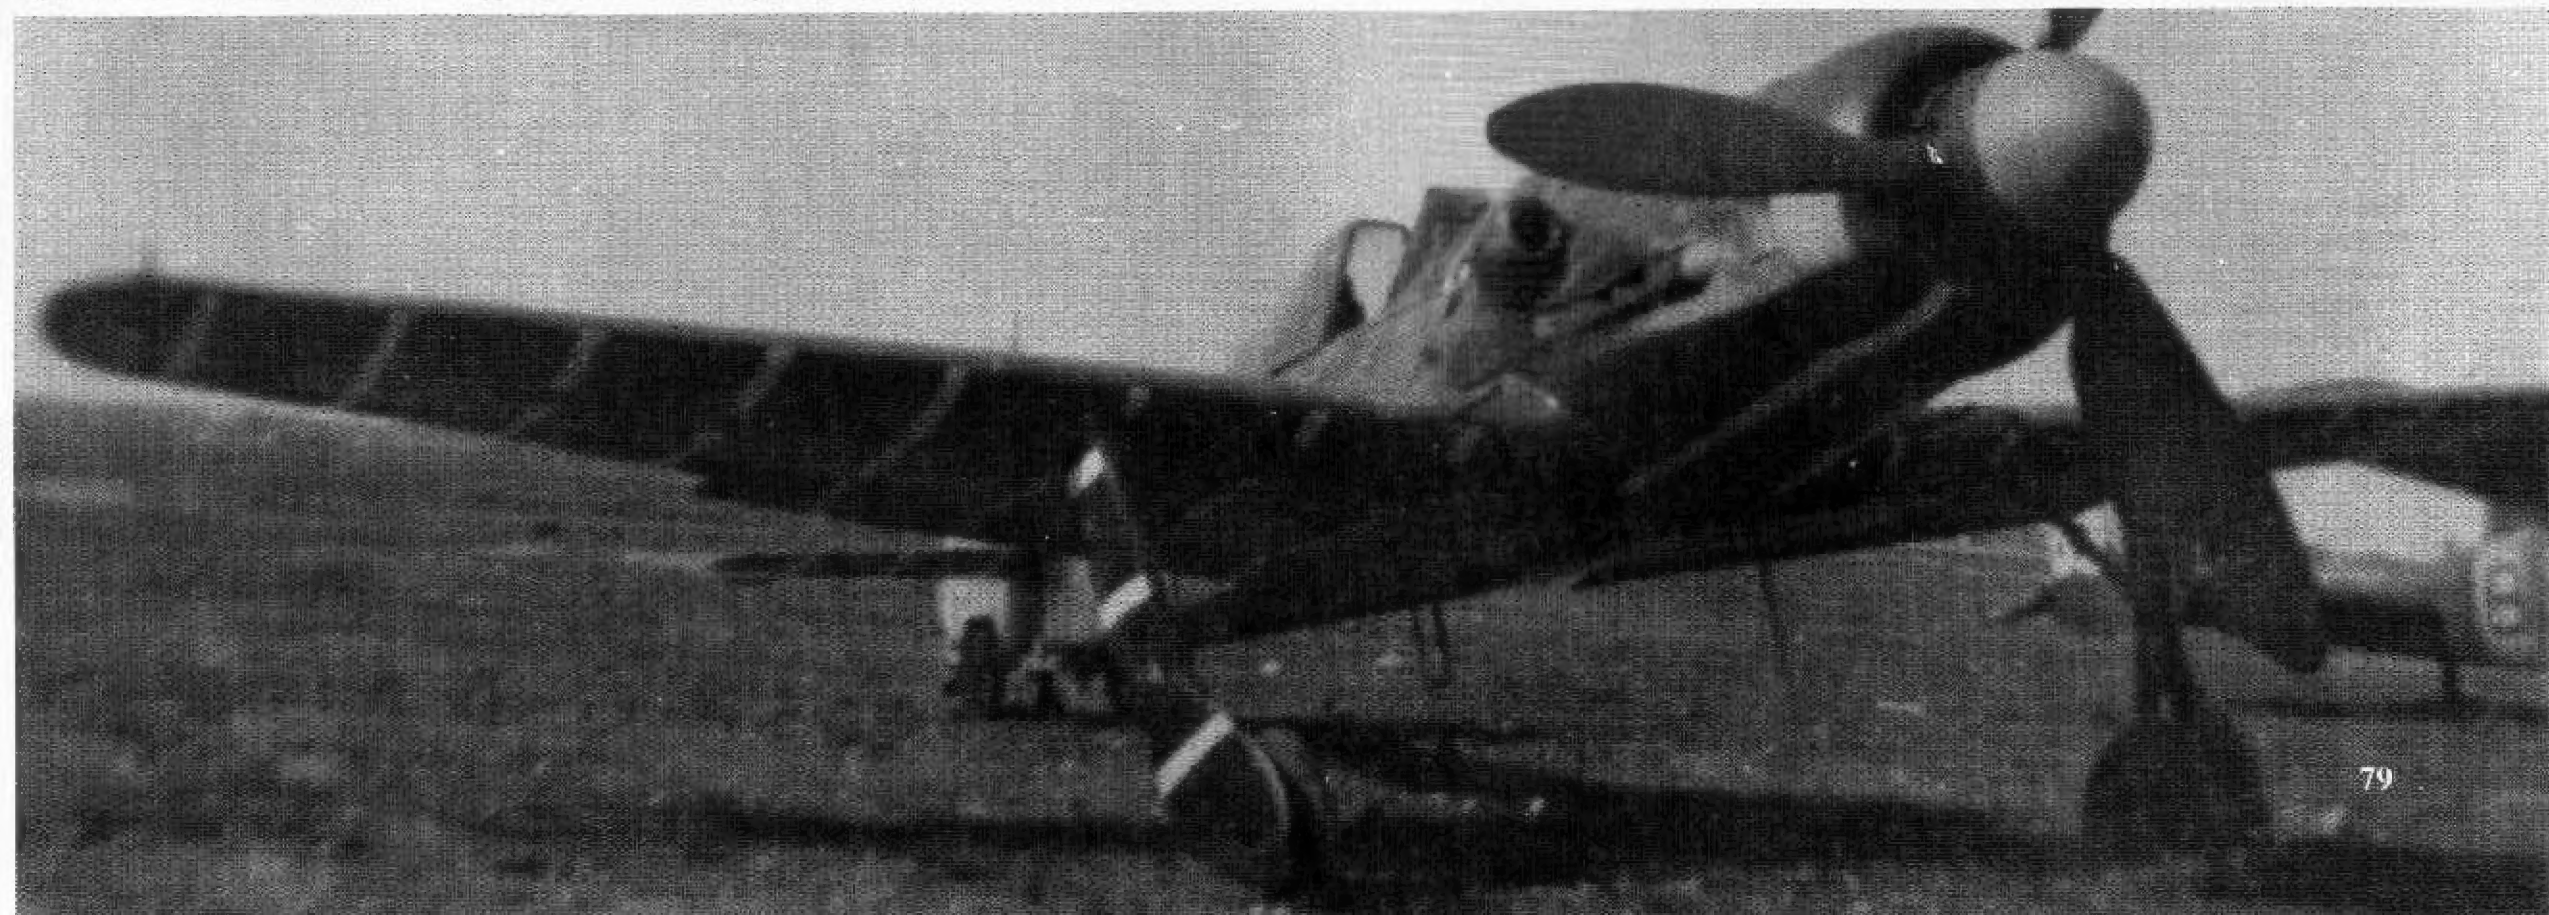
White <61, an Fw 190D-11 (the Work Number was previously listed as 350158, but is most probably 220004) at Bad Worishofen during the summer of 1945. The spinner and blades are in 70 and has an opening for an engine mounted cannon, but no cannon is installed. Fuselage is 83/75/76 with the fuselage being heavily over sprayed. 81 on tail. The fuse-

lage extension plug is either light 76 or natural metal. The aircraft's number is painted on the leading edge of the wing. Upper wing and stabilizer is 83/75. The Wing's bottom is metal with 76 only on trailing half.
